**THE RESTORATION OF ECOLOGICAL CONTINUITY
CORRIDORS ON MOTORWAYS**

MARCH 2023

REPORT
Specific feedback on
experience: assessment
of frequentation by
small mammals of a
footway under a hydraulic
structure fitted with a
hollow section

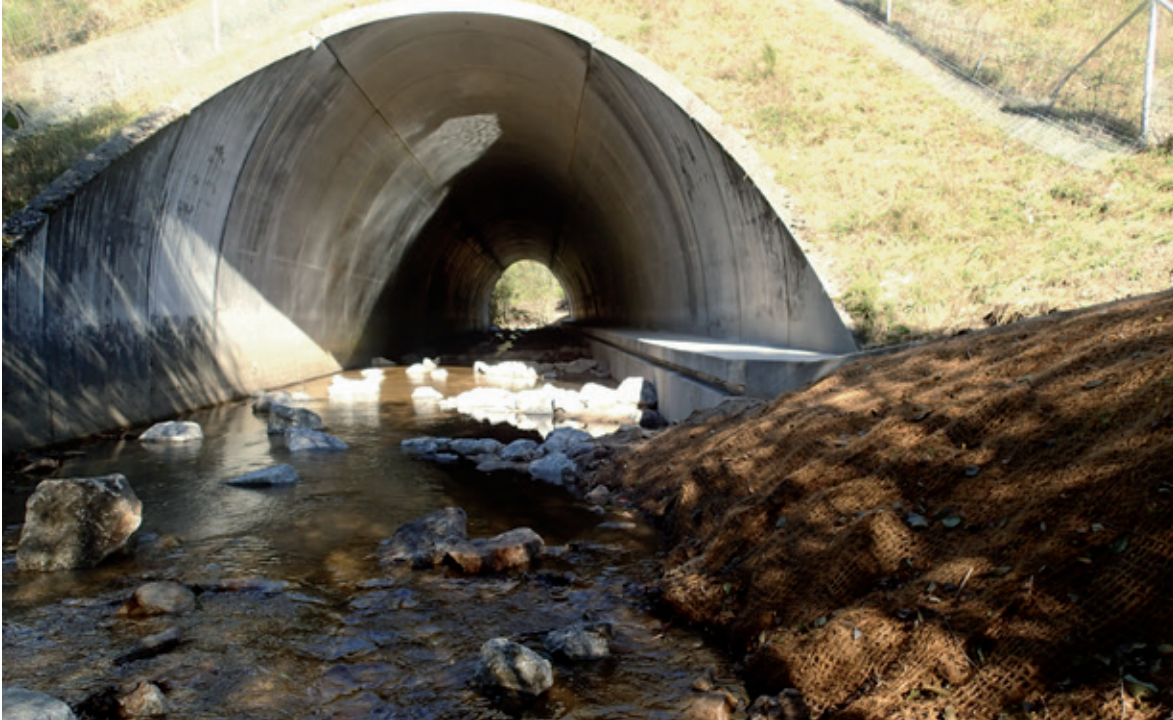
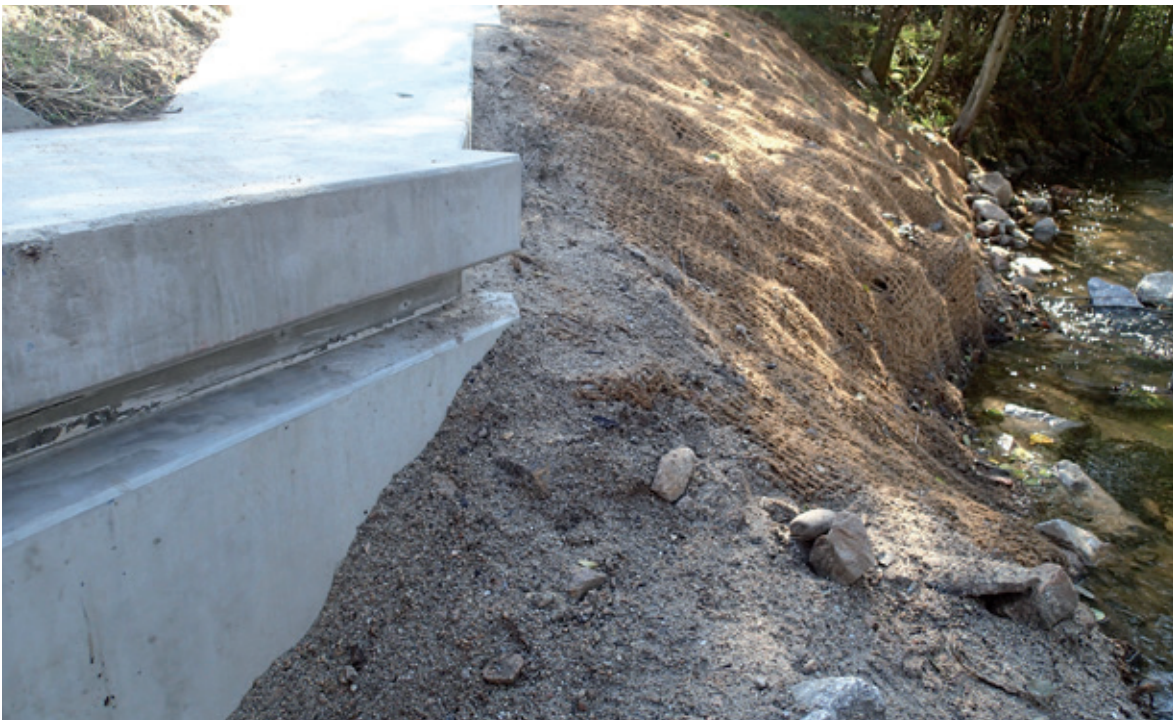
*Photoset 1: Illustrations of the structure and its remodelling for small wildlife (photos taken during the construction phase). © GREGE
Up: View of the Deiro structure - Down: View of the wildlife footway and hollered out "micromammals" section created and access to the downstream riverbank.*

In 2017, this 9-metre-wide structure was redesigned to re-establish the ecological continuity necessary for the crossing of the A89 by small wildlife (Photoset 1). Previously, the structure had already been fitted for wildlife by the creation of three tiered footways. However, the existing footways were considered unsuitable, given the permanent immersion of the lowest footway and the regular immersion of the second. Remodelling was therefore carried out.

A 1.20-metre-wide wildlife footway, 60 centimetres above the highest existing footway, was created on the left bank to allow species to move through the structure without getting wet throughout the year. In the side of this footway, 85 centimetres above the lowest existing footway, a “micromammal” pathway was specifically hollowed out for the Southwestern Water Vole. This arrangement, conceived and designed by the GREGE, has already been created previously in four structures on the Tours-Bordeaux high-speed trainline. The principle is based on obtaining better-covered and safer circulation of micromammals, by means of this 13-cm-wide and 10-cm-high hollowed section.

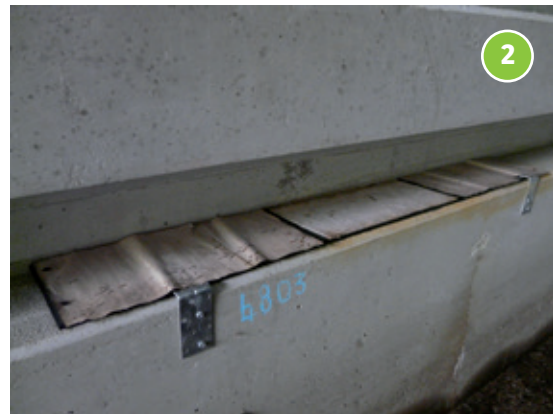
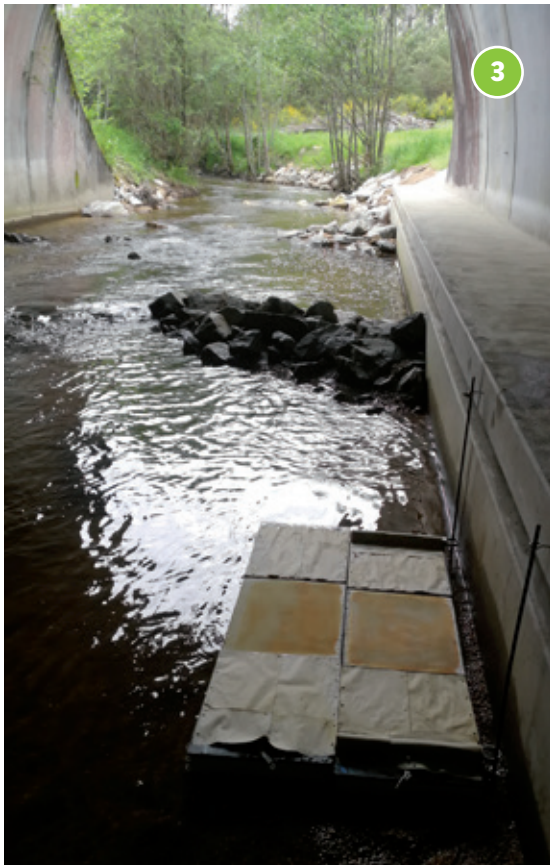
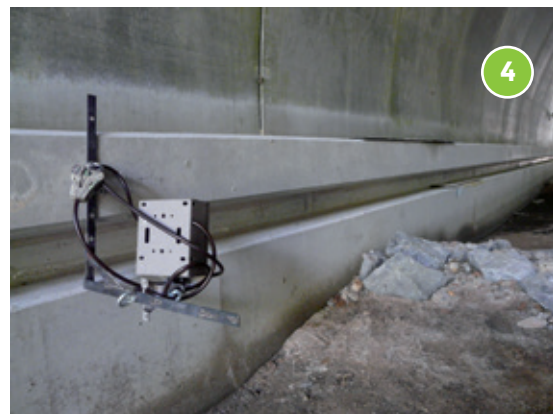
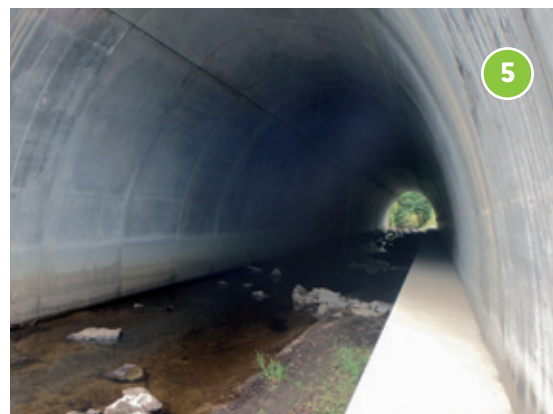
Photoset 3: Illustrations of three trackers used for monitoring frequentation of the Deiro structure. © GREGE

1 - Footprint trackers to monitor frequentation of wildlife footway © GREGE

2 - Footprint tracker set up in "small mammal" hollowed pathway © GREGE

3 - Footprint tracker set up in the riverbed to highlight potential movements (photo taken on 24/05/2018) © GREGE

4 - View of camera trap aimed at hollowed pathway and camera trap in the background aimed at the wildlife footway © GREGE

5 - View of the strip of sediment formed due to the presence of spurs created during remodelling (photo taken on 30/7/2019) © GMHL

In the framework of this monitoring, trackers were placed along the entire width of the various possible pathways, namely the wildlife footway, the "micromammal" pathway and the strip of sediment at the foot of the footway (Photoset 3; Figure 2).

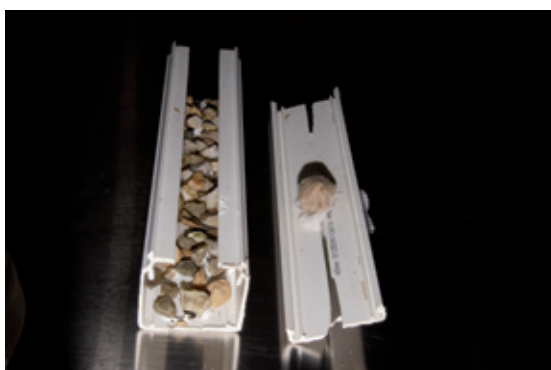
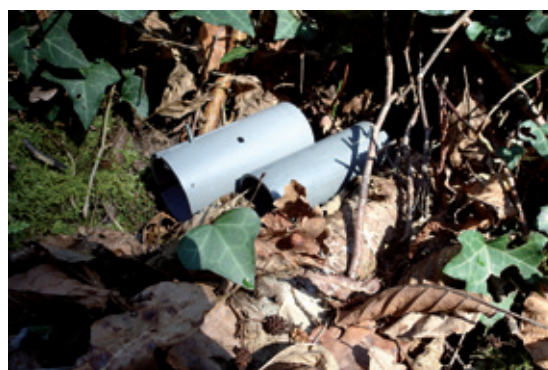
Photoset 4: Illustration of two baited trackers used. © GREGE
Left : Faeces tube / Right : Fur tubes

In 2020, two types of baited trackers were used (Photoset 4): faeces tubes, the bottom of which is covered with small pebbles to retain the droppings that the animal would deposit there, and fur tubes, which are equipped with adhesive plates that collect fur as the animal passes.

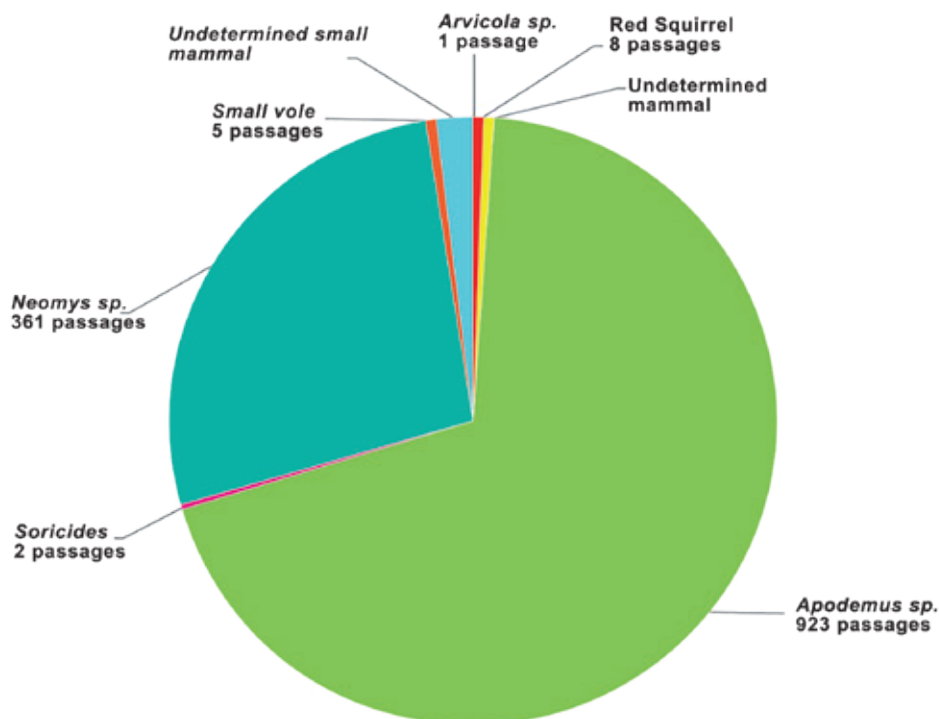
Figure 3: Distribution of the 1331 passages detected in the “micromammal” hollow pathway by camera trap over the 935 nights of monitoring.

Over the entire camera trap monitoring period of 935 nights, 1330 passages were observed in this hollowed pathway, and five species or groups of species were detected (Figure 3). These passages include 69.3% (923 passages) of *Apodemus sp.* and 27.12% (361 passages) of *Neomys sp.* In addition, red squirrels passed on eight occasions, small voles were detected on

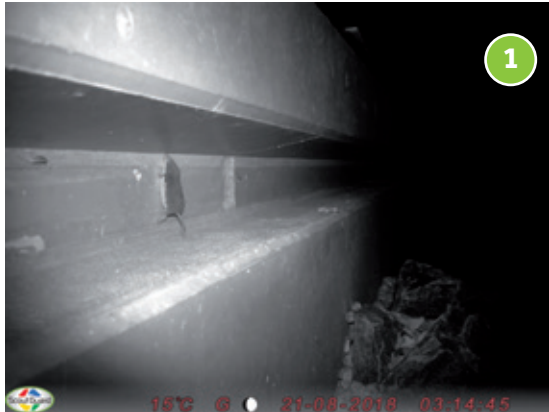
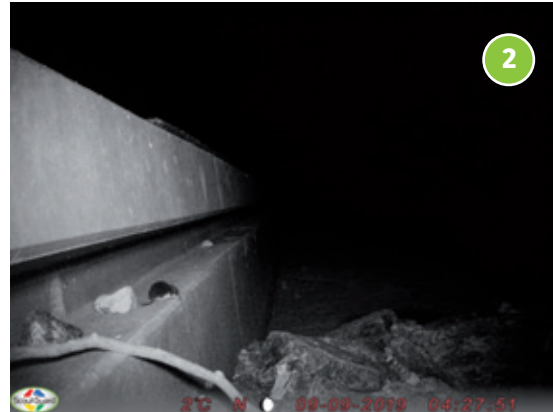
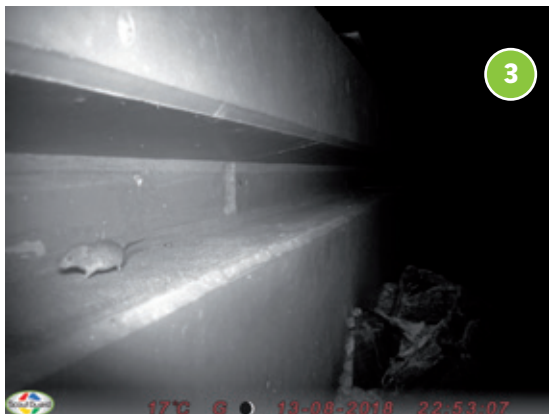
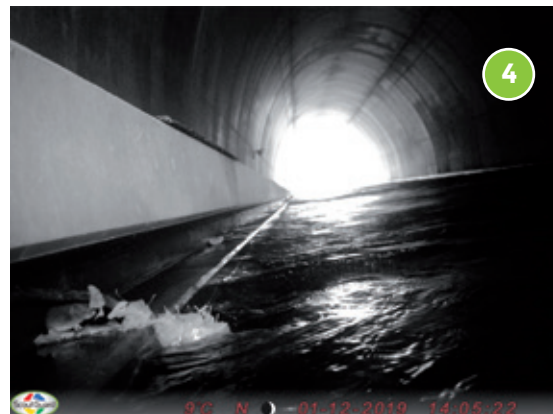
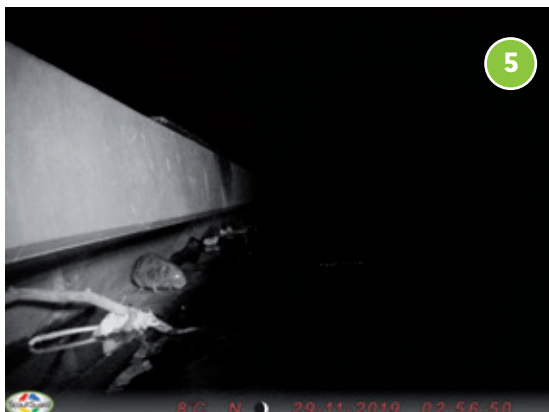
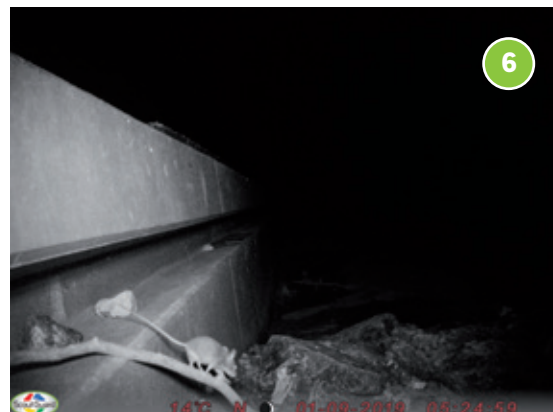
Photoset 5:

**ILLUSTRATIONS OF THE FOUR SPECIES GROUPS DETECTED BY CAMERA TRAP
IN THE "MICROMAMMAL" HOLLOWED PATHWAY.**

1 - *Neomys sp. hunting* © GREGE

five occasions, and **an individual of the genus *Arvicola sp.* was observed in the hollowed pathway on November 29, 2019. (Photoset 5).** Monthly analysis by species group shows strong monthly variations with peaks in spring and summer and an increase in use until 2020, particularly for the field mouse group (Figure 4). On the other hand, for the group of aquatic shrews of the genus *Neomys sp.*, the frequentation was very early, even almost exclusively, shortly after the end of the construction work. As for field mice, the peak of passages occurred in August 2018 and 2019, and the number of recorded visits decreased over the years (Figure 5), with only sporadic visits in 2020 and 2021.

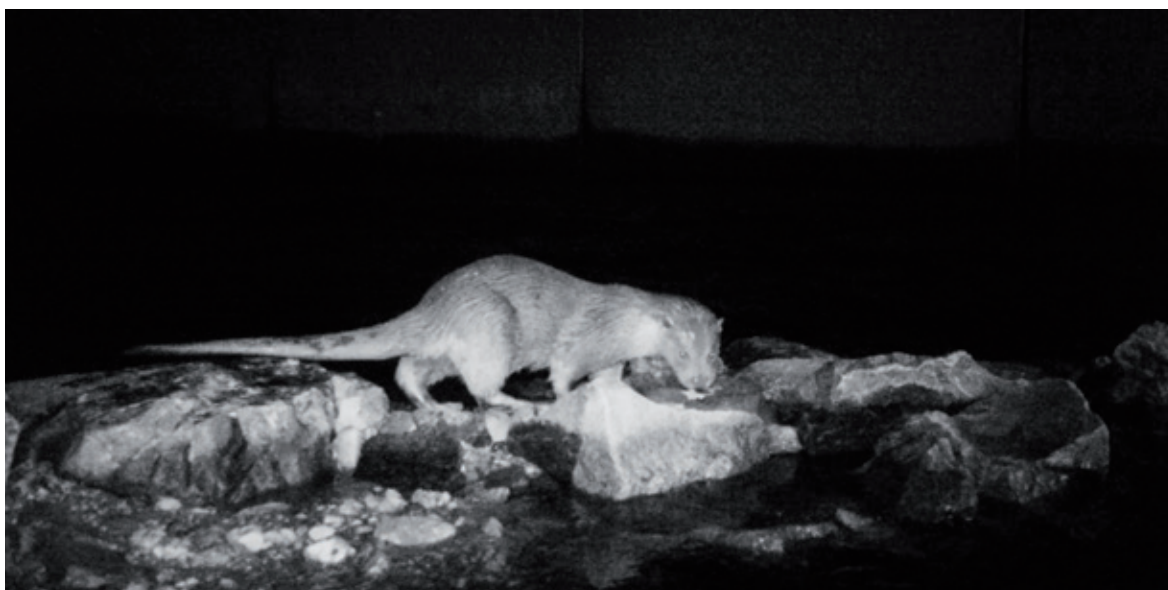
Planche-photos 6 : Otter detected by the camera trap targeting one of the spurs in the riverbed. © GREGE

As such, 74 passages, attributed to seven species or groups of species were detected by the footprint tracker, against 298 passages and twelve species for the camera traps (Photosets 6 & 8).

A total of thirteen species were recorded roaming on this strip of sediment (Table IV): the two amphibian groups, two domestic carnivores, a Coypu, four small carnivores, including the Stoat and the European Otter (*Lutra lutra*), the Red Squirrel, two small micromammals (including the genus *Neomys sp.*) and two large micromammals (including the genus *Arvicola sp.*)

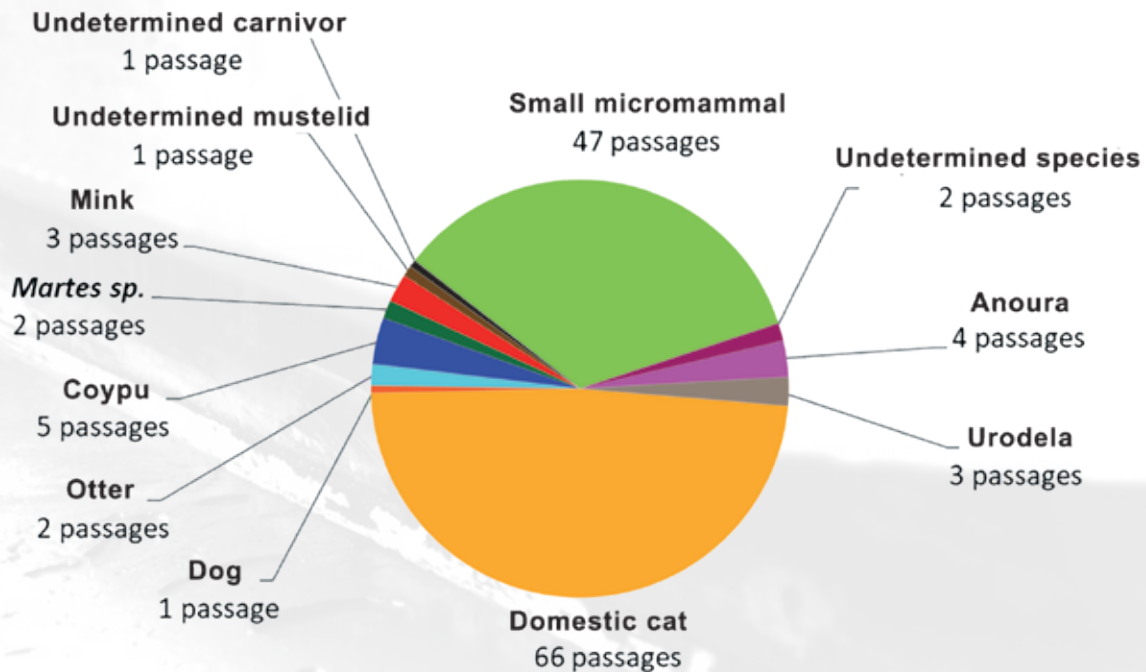
Figure 6: Distribution of the 137 passages recorded on the wildlife footway using footprint trackers over 350 nights of monitoring.

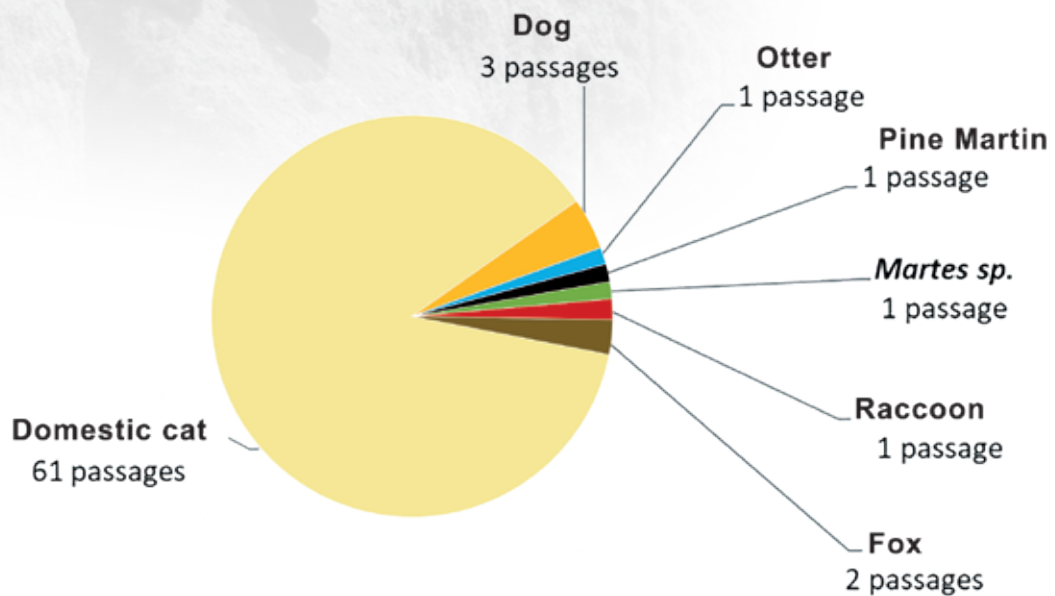
Figure 7: Distribution of the 70 passages recorded on the wildlife footway using a camera trap over 443 monitoring nights.

Over the entire camera trap monitoring, i.e., 443 nights, 70 passages were observed on the wildlife footway, attributed to six carnivore species (Figure

7), among which domestic carnivores represent 91.4% of the passages. An exceptional datum is to be noted: a Raccoon was detected at the beginning of the night on June 20, 2019. .

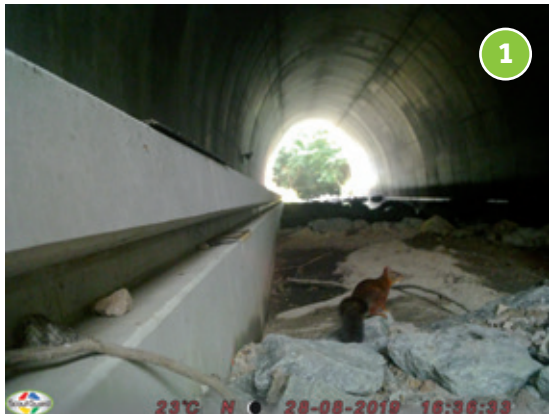
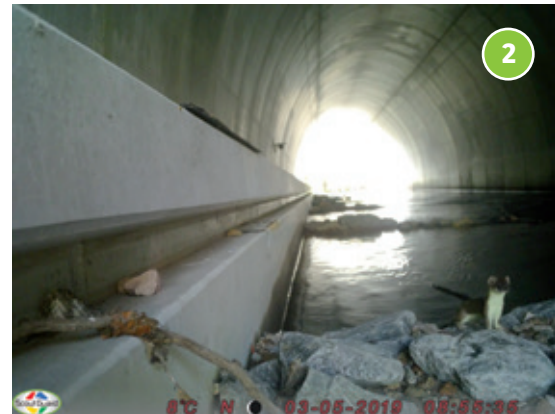
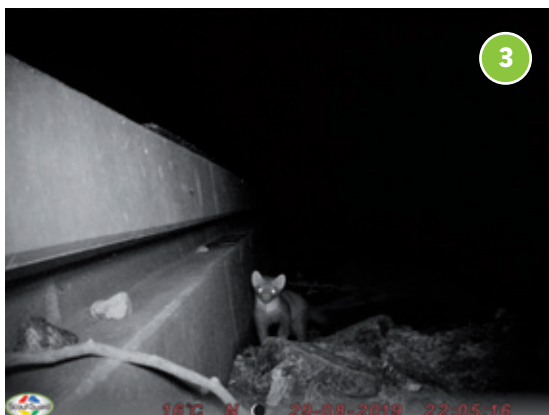
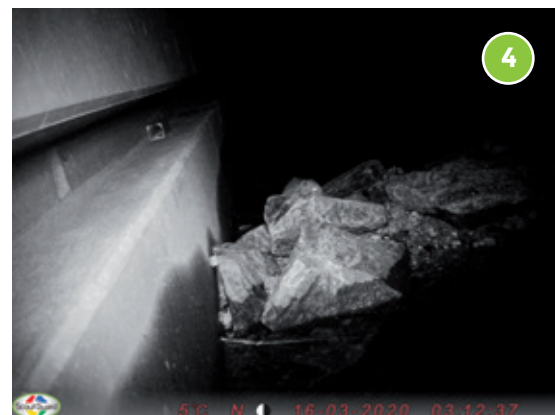
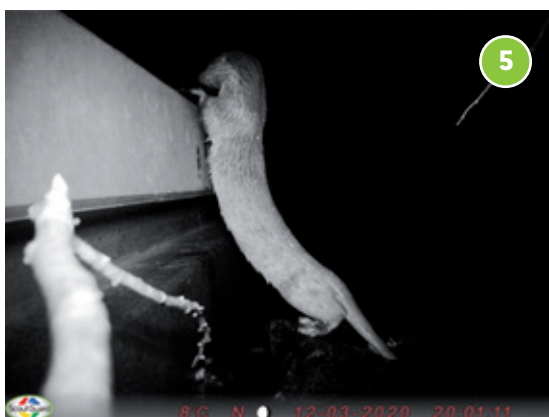
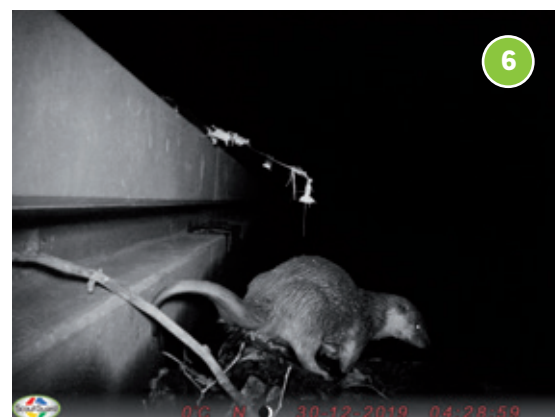
Photoset 8 :

ILLUSTRATIONS OF VARIOUS OBSERVATIONS MADE BY A CAMERA TRAP SET UP IN THE FRAMEWORK OF MONITORING THE "MICROMAMMALS" HOLLOWED SECTION. © GREGE/GMHL

1 - Red Squirrel

The camera trap targeting the hollowed section was used to observe flooding events and to estimate, without being exhaustive, the duration of certain periods of submersion of the hollowed section (Photoset 8). Several flooding episodes were thus observed from November 2019 to August 2021, during which the photos show water arriving just under the hollowed section, then partially or totally flooding it. In total, the "micromammals" hollowed section seems to have been flooded, or even totally underwater, for at least 33 days spread between November/December 2019 and August 2021, with between one and nine consecutive days per flooding event. The duration of non-effectiveness therefore remains very low.

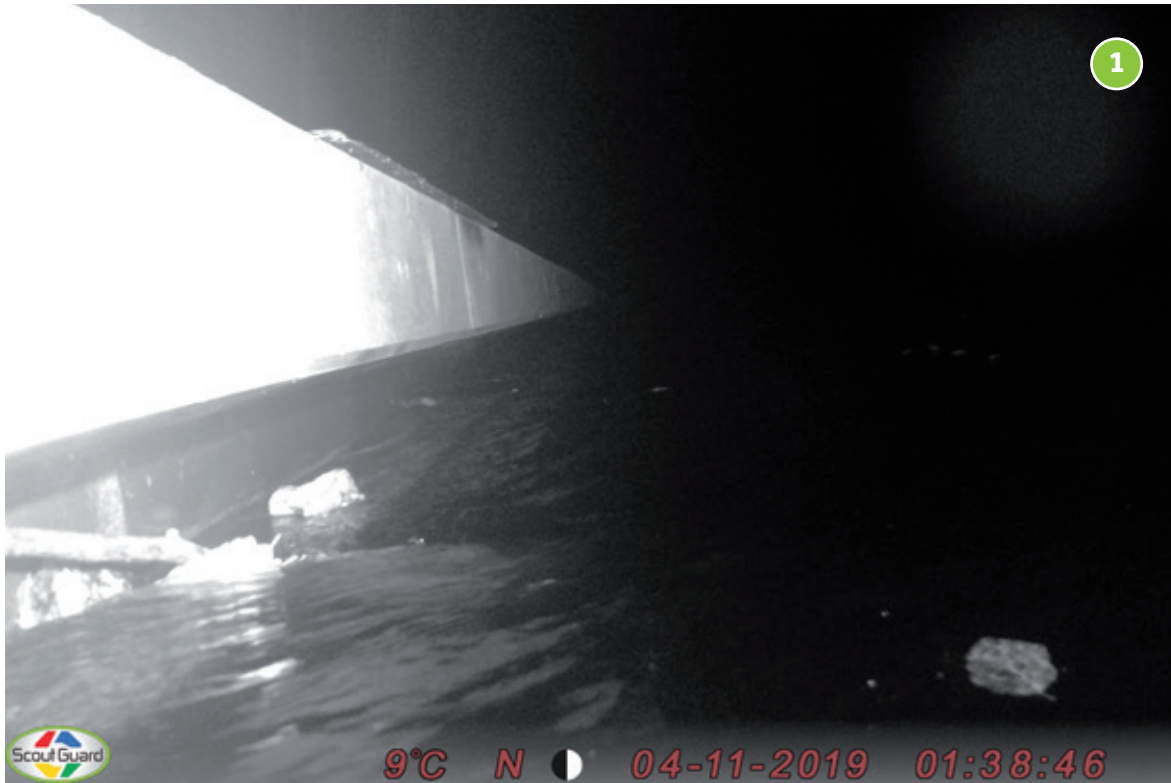
ILLUSTRATIONS OF VARIOUS OBSERVATIONS MADE BY A CAMERA TRAP SET UP IN THE FRAMEWORK OF MONITORING THE "MICROMAMMALS" HOLLOWED SECTION. © GREGE/GMHL.

- 1 - "Micromammals" hollowed section flooded © GREGE/GMHL
- 2 - "Micromammals" hollowed section totally underwater © GREGE/GMHL
- 3 - Camera trap underwater © GREGE/GMHL
